# A Discussion on Ruby-Glass Composites & Their Potential Impact on the Nomenclature in use for Fracture-Filled or Clarity Enhanced stones in General

Kenneth Scarratt

GIA Laboratory, Bangkok

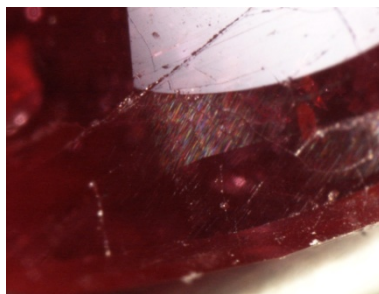
Figure 3: Rutile needles (silk) in a ruby-glass composite; the silk is unaltered by heating

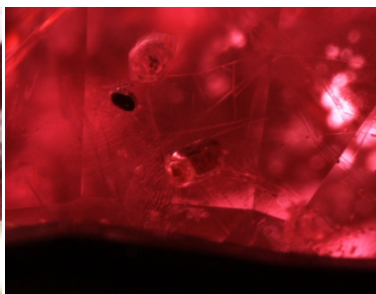
Figure 4: An hexagonal crystal in a ruby-glass composite; the crystal is unaltered by heating

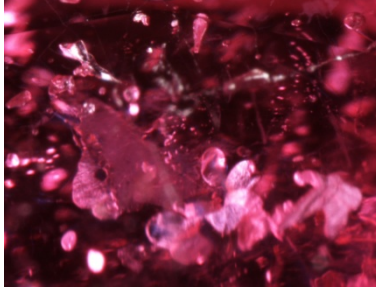
Figure 10: RGC001 flattened bubbles within filled fractures

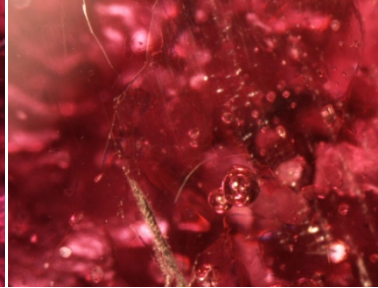
Figure 11:RGC005 expanded bubbles within filled fractures

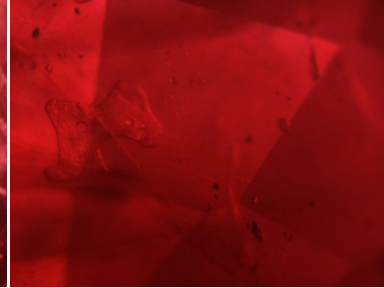
Figure 12:RGC006 flattened bubbled within filled fractures

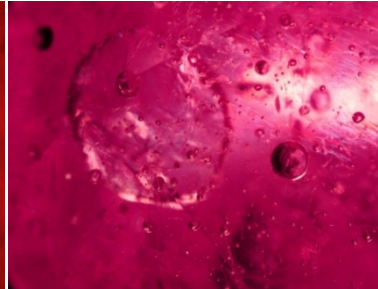
Figure 14:RGC007 flattened and expanded bubbles within filled fractures

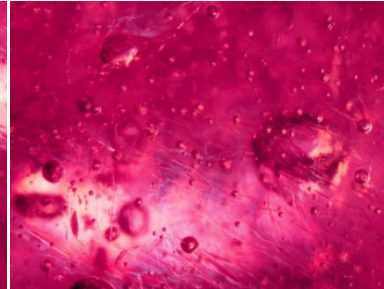
Figure 15:RGC007 flattened and expanded bubbles within filled fractures

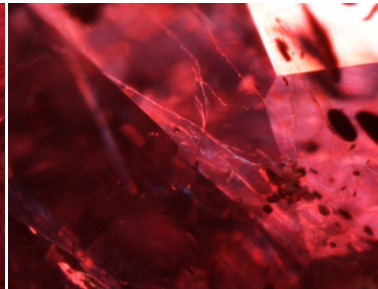
Figure 17:RGC008 color flashed from revealing the glass filled fractures

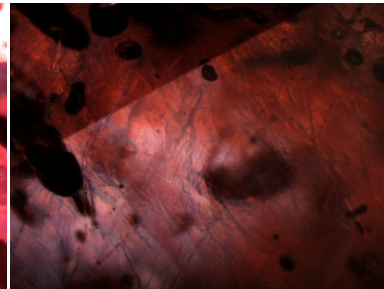
Figure 18:RGC011 color flashed from revealing the glass filled fractures

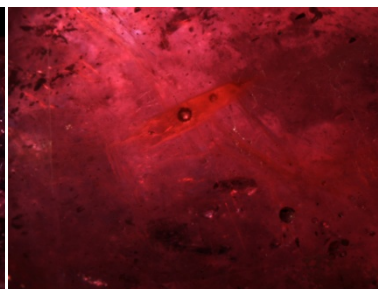
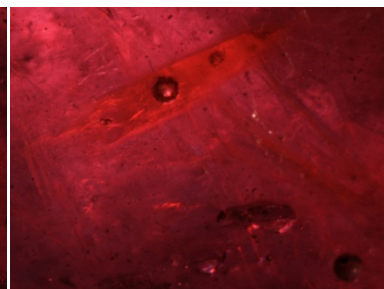
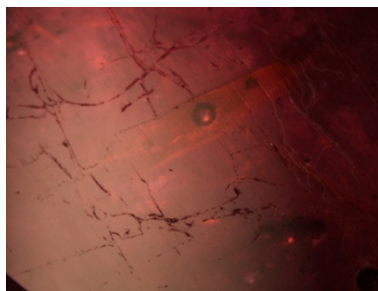
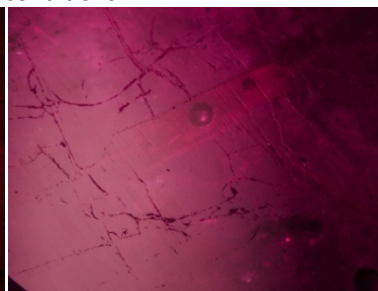
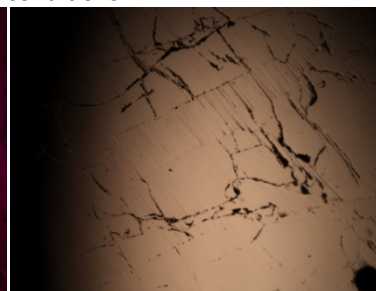
In one case the microscope revealed that the glass being used has an orange color (Figure 20 to Figure 24). Such orange colored glass is described by Pardieu (Pardieu, 2005) where he states "*In rubies enhanced in Bangkok by Orange Sapphire company, some yellow to orange color concentration appears in large fissures and in cavities*". A statement supported by images that compare well with Figure 20 to Figure 24. He

Figure 20: RGC015 orange glass

Figure 21: RGC015 orange glass

Figure 22: RGC015 orange glass filling a cavity and fracture. Figure 20 to Figure 24 show this in different lighting conditions

Figure 23: RGC015 orange glass filling a cavity and fracture. Figure 20 to Figure 24 show this in different lighting conditions

Figure 24: RGC015 orange glass filling a cavity and fracture. Figure 21to Figure 23 show this in different lighting conditions

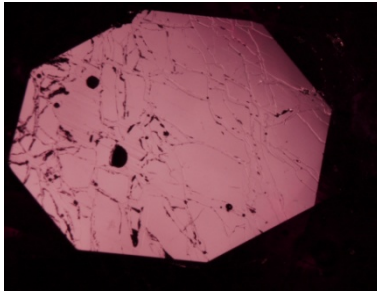
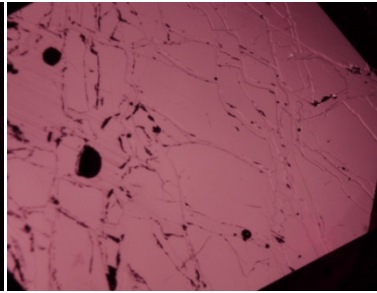
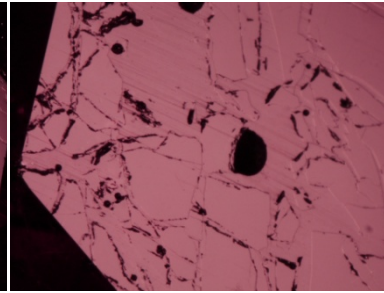
Figure 40: RGC007 this NTSR image of the table facet reveals a virtual jigsaw puzzle of glass and ruby – islands of ruby in a glass matrix

Figure 41: RGC007 (magnified from Figure 40) this NTSR image of the table facet reveals a virtual jigsaw puzzle of glass and ruby – islands of ruby in a glass matrix

Figure 42: RGC007 (magnified from Figure 41) this NTSR image of the table facet reveals a virtual jigsaw puzzle of glass and ruby – islands of ruby in a glass matrix

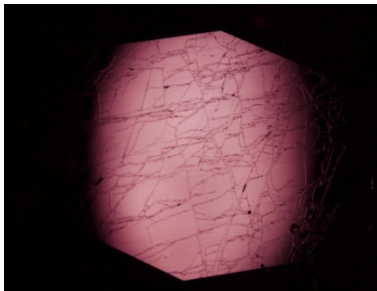
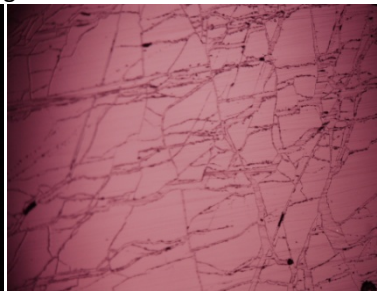
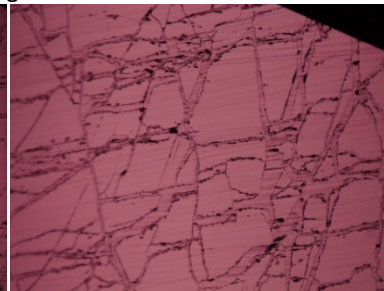
Figure 43: RGC010 as in RGC007 this NTSR image of the table facet also reveals a virtual jigsaw puzzle of glass and ruby – islands of ruby in a glass matrix

Figure 44: RGC010 (magnified from Figure 43) as in RGC007 this NTSR image of the table facet also reveals a virtual jigsaw puzzle of glass and ruby – islands of ruby in a glass matrix

Figure 45: RGC010 (magnified from Figure 44) as in RGC007 this NTSR image of the table facet also reveals a virtual jigsaw puzzle of glass and ruby – islands of ruby in a glass matrix

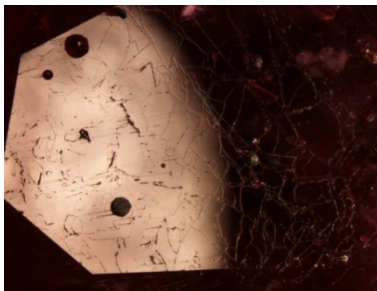
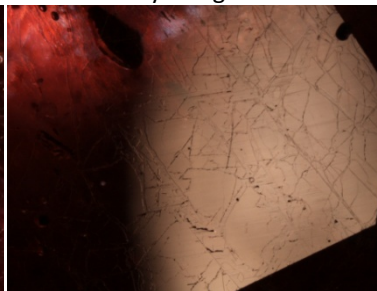
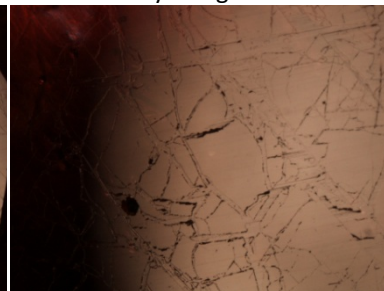
Figure 46: RGC011 as in RGC007 and RGC 010 this NTSR image of the table facet also reveals a virtual jigsaw puzzle of glass and ruby – islands of ruby in a glass matrix

Figure 47: RGC011 (magnified from Figure 46) as in RGC007 and RGC 010 this NTSR image of the table facet also reveals a virtual jigsaw puzzle of glass and ruby – islands of ruby in a glass matrix

Figure 48: RGC011 (magnified from Figure 47) as in RGC007 and RGC 010 this NTSR image of the table facet also reveals a virtual jigsaw puzzle of glass and ruby – islands of ruby in a glass matrix

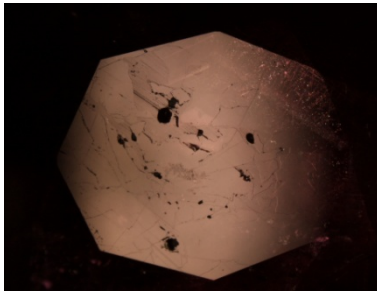
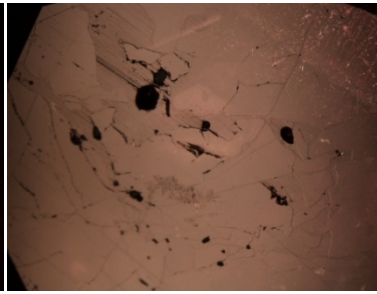
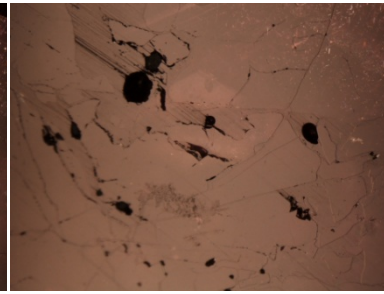
Figure 49: RGC006 as in RGC007, RGC 010 and RGC011 this NTSR image of the table facet also reveals a virtual jigsaw puzzle of glass and ruby – islands of ruby in a glass matrix

Figure 50: RGC006 (magnified from Figure 49) as in RGC007, RGC 010 and RGC011 this NTSR image of the table facet also reveals a virtual jigsaw puzzle of glass and ruby – islands of ruby in a glass matrix

Figure 51: RGC006 (magnified from Figure 50) as in RGC007, RGC 010 and RGC011 this NTSR image of the table facet also reveals a virtual jigsaw puzzle of glass and ruby – islands of ruby in a glass matrix

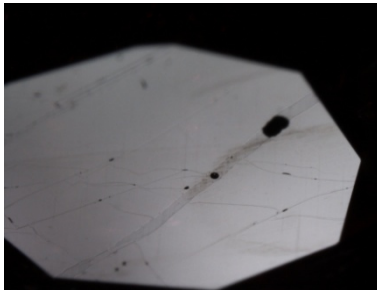
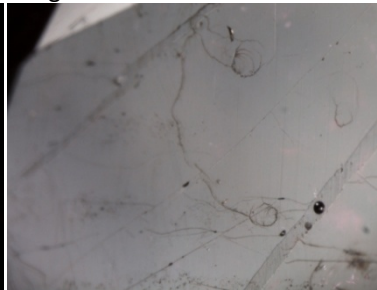
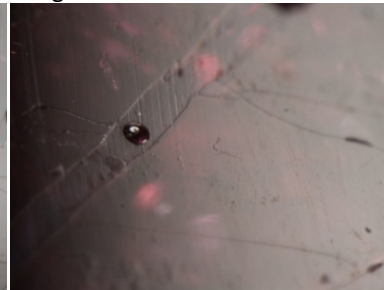
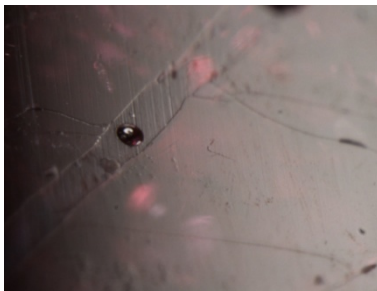
Figure 52: RGC002 showing a wide tract of glass crossing the table facet in NTSR, two bubbles are seen cut through at the surface

Figure 53: RGC002 showing a wide tract of glass crossing the table facet in NTSR, highlighted area on the same facet seen in Figure 52.

Figure 54 RGC002 showing a wide tract of glass crossing the table facet in NTSR, highlighted area on the same facet seen in Figure 52

Figure 55: RGC002 showing a wide tract of glass crossing the table facet in NTSR, highlighted area on the same facet seen in Figure 52

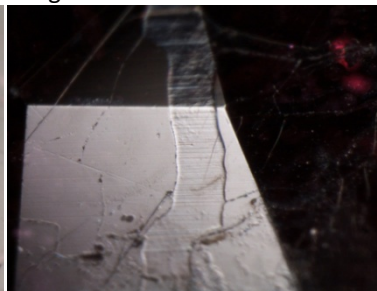
Figure 56: RGC003 showing a wide tract of glass crossing a facet in NTSR

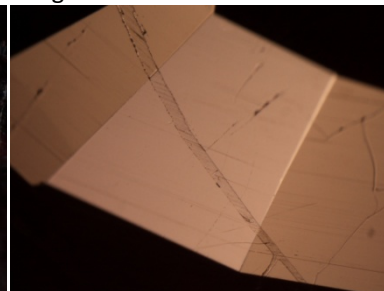
Figure 57: RGC004 showing a wide tract of glass crossing a facet in NTSR

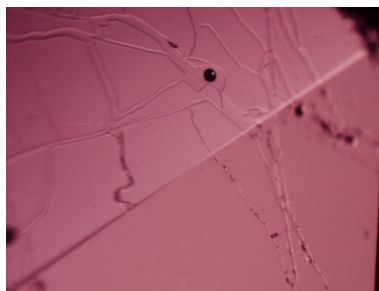
Figure 58:RGC007 showing several wide tracts of glass crossing two facets in NTSR

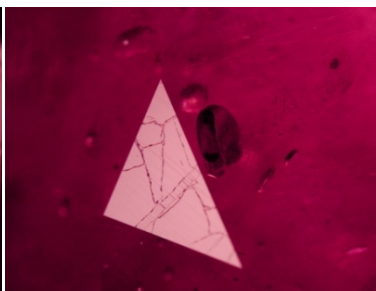
Figure 59:RGC010 showing wide and narrow tracts of glass crossing a facet in NTSR

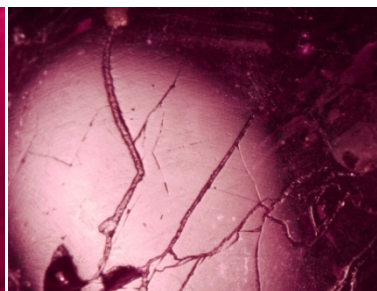
Figure 60:RGC012 showing wide and narrow tracts of glass crossing a facet in NTSR

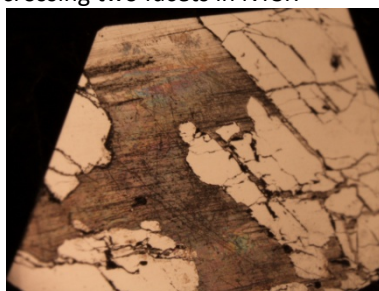
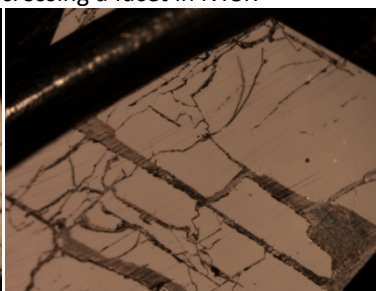
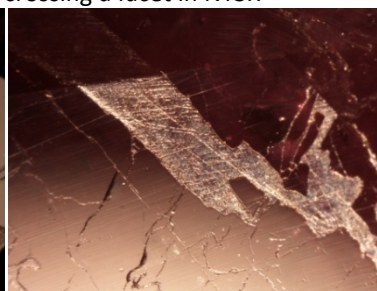
Figure 61:RGC014 showing wide tracts of glass crossing a facet in NTSR, The proportion of ruby to glass is in the region of 50/50

Figure 62: RGC014 showing wide tracts of glass crossing a facet in NTSR.

Figure 63:RGC014 showing wide tracts of glass crossing a facet in NTSR.

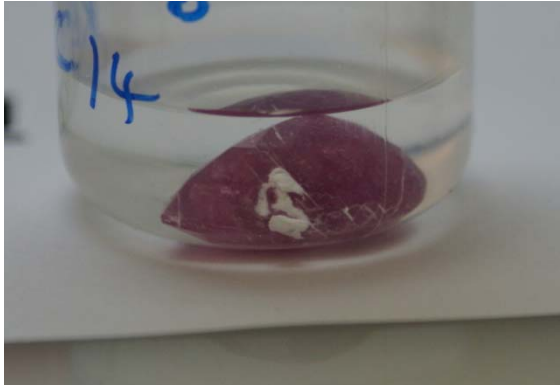
Figure 64: RGC014 seen here immersed in hydrofluoric acid. The white substance is residue from disintegration of the glass by the acid. The disintegration process begins as soon as the stone is placed in the acid. This image is taken within 30 minutes of immersion.

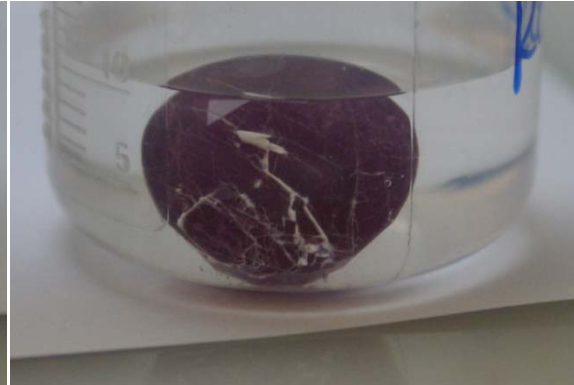
Figure 65: RGC015 seen here immersed in hydrofluoric acid. The white substance is residue from disintegration of the glass by the acid. The disintegration process begins as soon as the stone is placed in the acid. This image is taken within 30 minutes of immersion.
