# A Discussion on Ruby-Glass Composites & Their Potential Impact on the Nomenclature in use for Fracture-Filled or Clarity Enhanced stones in General

Kenneth Scarratt

GIA Laboratory, Bangkok

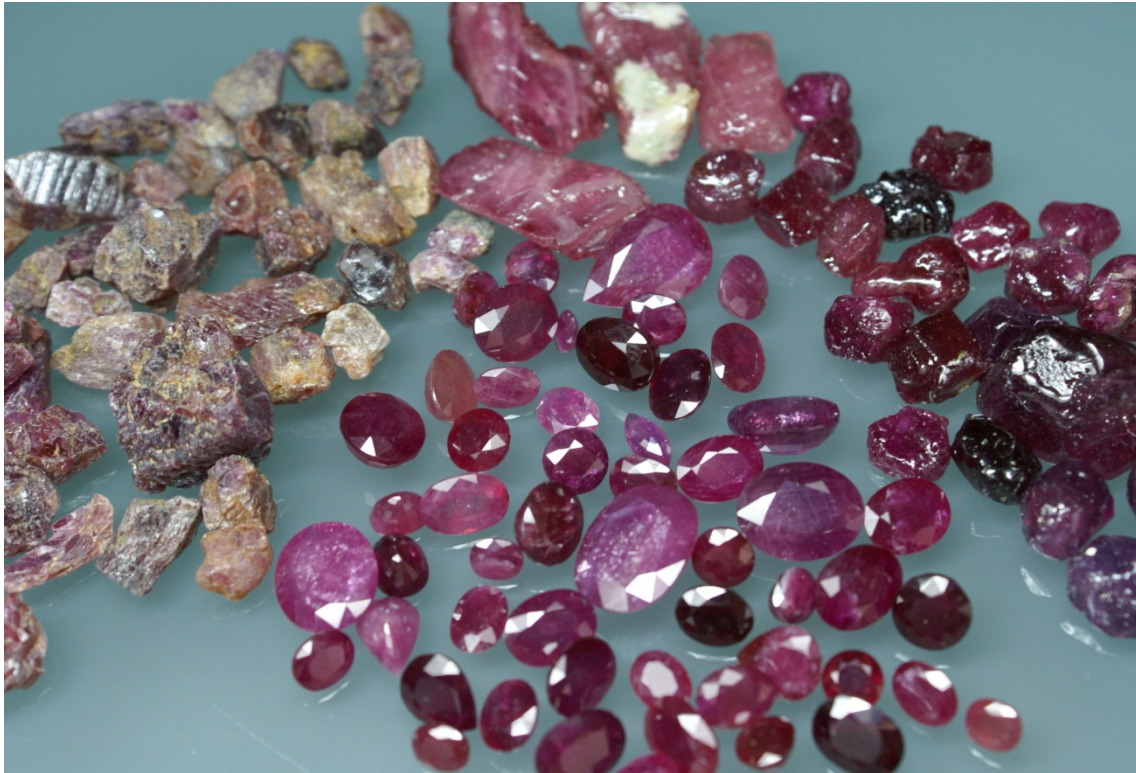
Figure 1: Some of the specimens used for this report. The rough specimens on the left represent the starting material, the specimens top and right represent the treated rough, and the specimens at center are cut from the treated rough.

As seen in Figure 1 and confirmed through industry contacts the start material for the product described here is extremely low quality corundum and further the assumption is that the material cannot be cut and faceted as mined. This assumption is confirmed in part both through industry contacts and our own observations that the material has to be “infused” with glass prior to cutting and faceting (see again Figure 1).
