# A Discussion on Ruby-Glass Composites & Their Potential Impact on the Nomenclature in use for Fracture-Filled or Clarity Enhanced stones in General

Kenneth Scarratt

GIA Laboratory, Bangkok

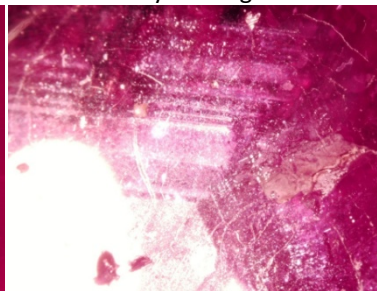
Figure 8: Rutile needles (silk) in an hexagonal formation in a ruby-glass composite; the silk is unaltered by heating

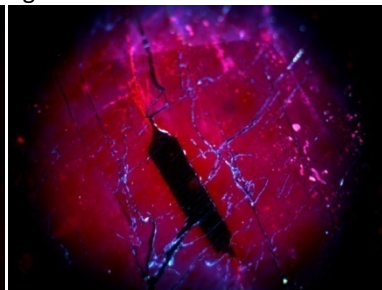
In an attempt to further categorize (visually) the volume of glass used in the ruby-glass composites, 15 of the samples were examined and images recorded with the DiamondView™ (Diamond Trading Company). These images are produced here from Figure 25 to Figure 39. This exercise was rewarding in that it quickly recorded images that allowed for a close estimation of the position and volume of glass present in each stone. In particular stones RGC011 and RGC015 revealed copious amounts of glass.

DiamondView™ (Diamond Trading Company) images of specimens RGC001 to RGC015. Glass reveals itself as either black or blue tracts running across each stone. The brighter red areas reflect the positions of gas bubbles. Sample numbers are given for each stone.

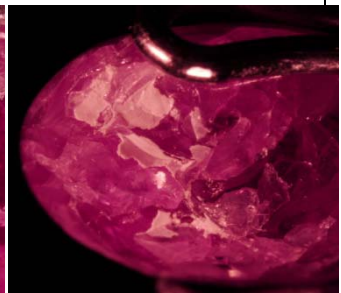
Figure 69: RGC001 after acid disintegration.

The acid began to visually disintegrate the glass within minutes of immersion (Figure 64 and Figure 65). As immersion progressed and the acid disintegrated the glass further so small parts of the stones began to fall off from the main body of each specimen (Figure 66 to Figure 81). Longer immersion resulted in the stones falling into many pieces (Figure 96 to Figure 121) and in one case a total disintegration occurred (Figure 89 to Figure 92).
